SUMMARY October 2011

The West Branch Susquehanna

A WATERSHED IN RECOVERY

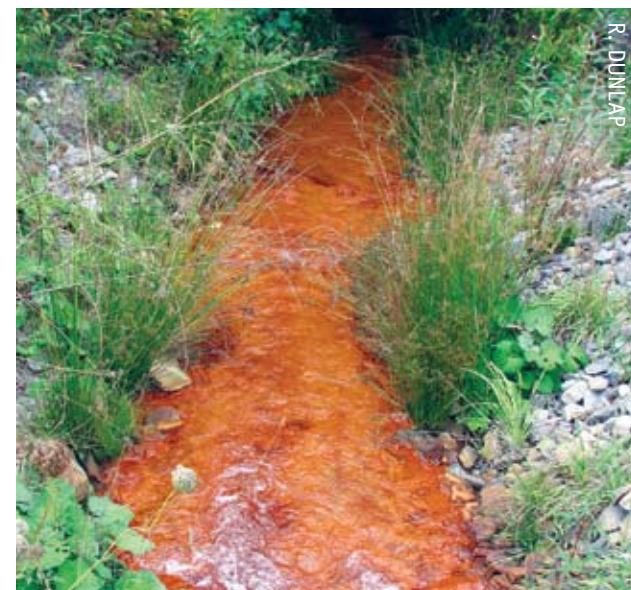
Deep mine in the Kettle Creek watershed, Clinton County

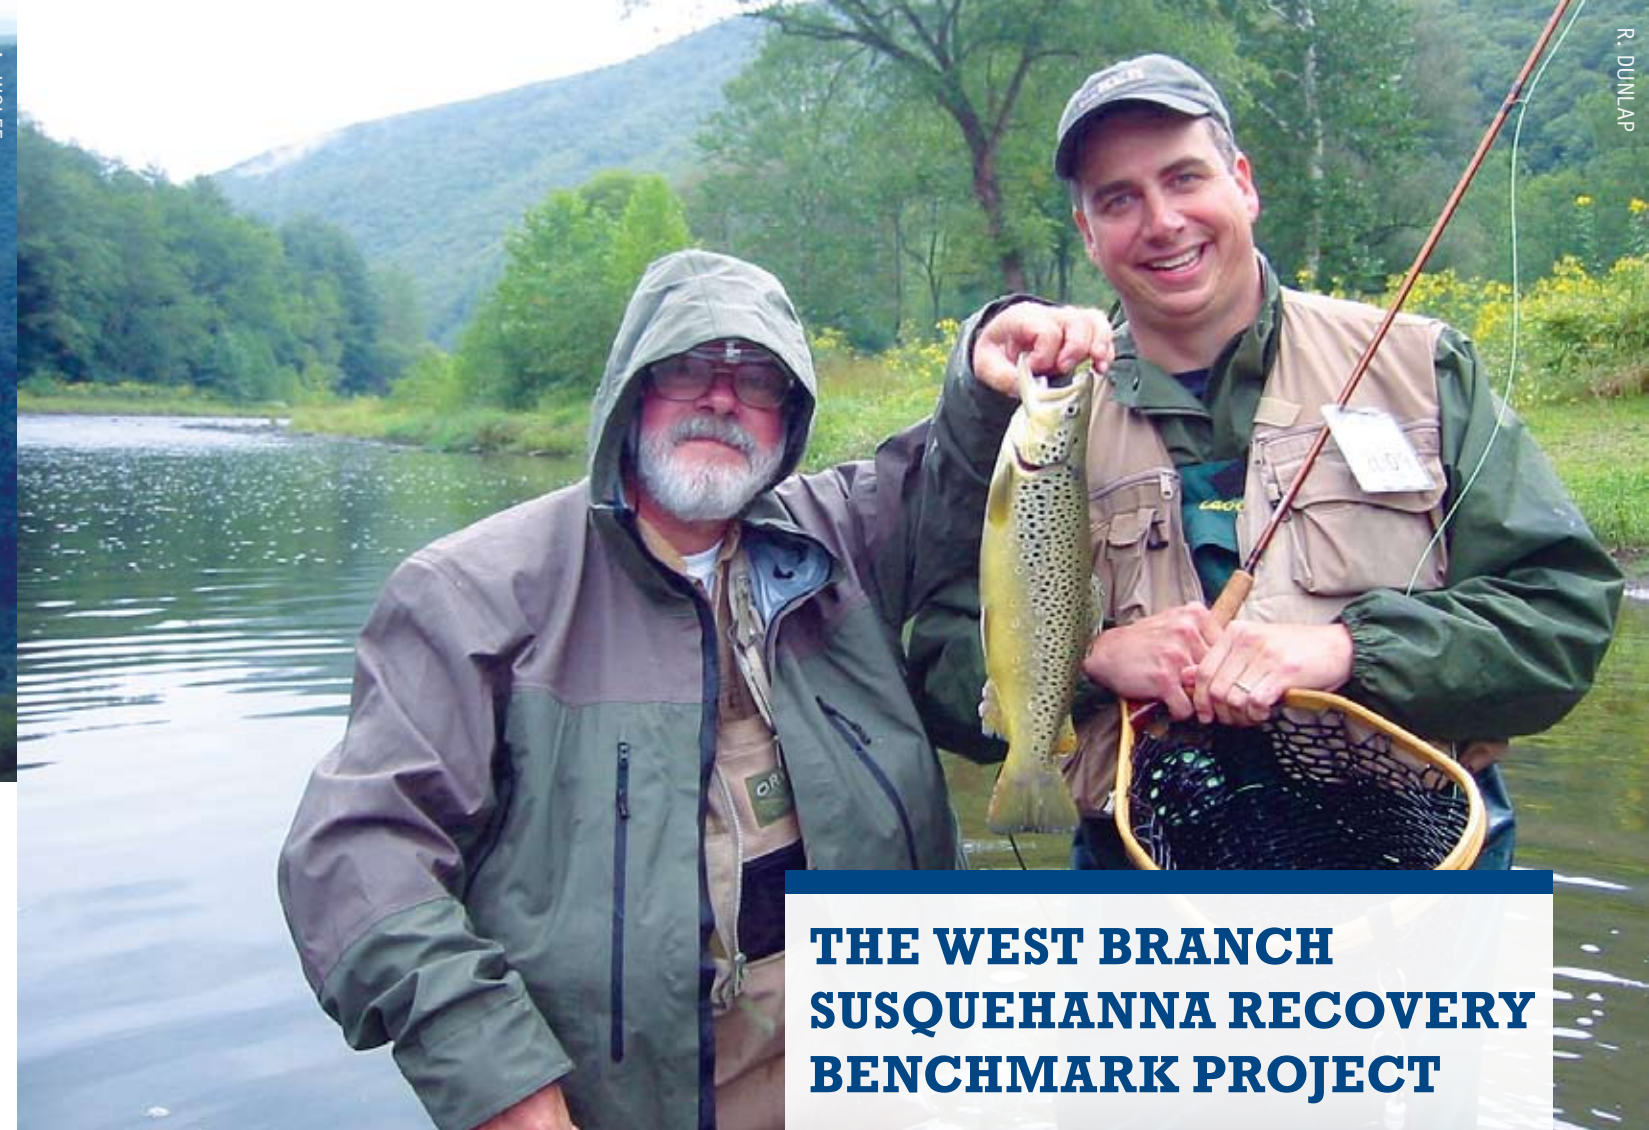
White Oak AMD discharge near Madera, Clearfield County

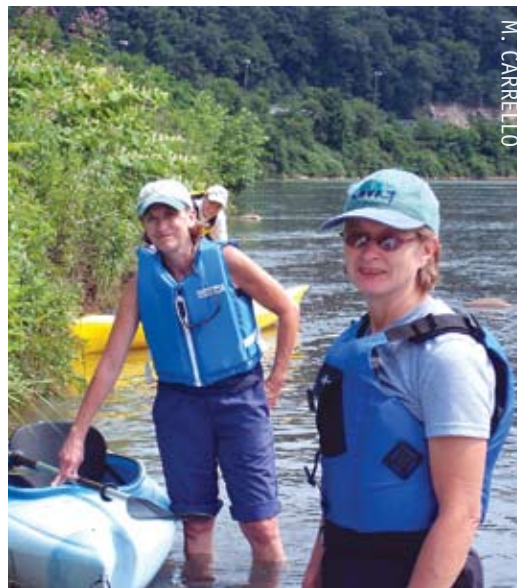
PA Fish and Boat Commission staff conduct fish surveys on the river at Hyner.

to Lock Haven by the PA Fish and Boat Commission was conducted in 1998 and 1999. For the purposes of this project, the PA Fish and Boat Commission resurveyed nine of 12 historic sampling locations. Sampling occurred at sites along a section of the river that encompasses approximately 144 miles of the river from Shyrock Run in Clearfield County downstream to Hyner in Clinton County. Fish surveys were conducted using backpack and mini-boom boat electrofishing gear according to the same protocol utilized in the 1998 and 1999 surveys.

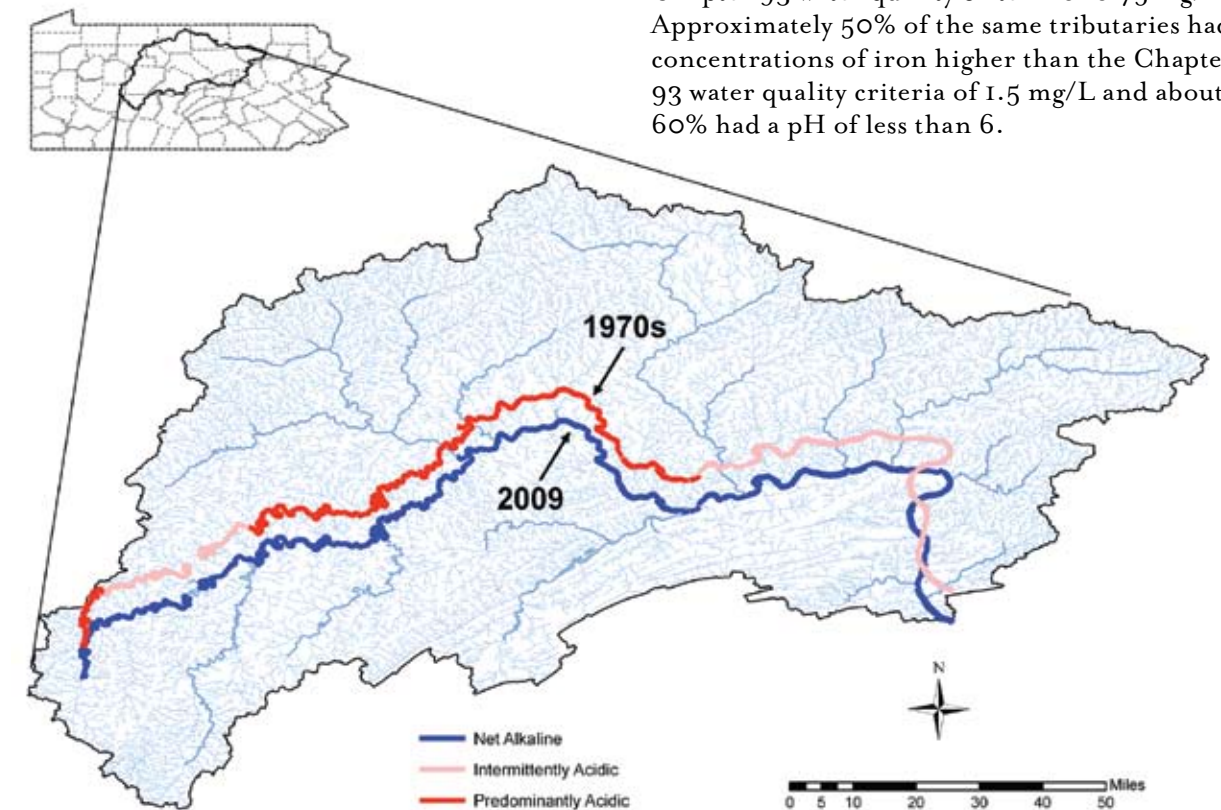
Map compares predominantly acidic river in the early 1970s to a near net alkaline condition in 2009.

Water quality today in the West Branch Susquehanna River and many of its tributaries is significantly better than it was according to a study conducted in the early 1970s and even when compared to the 1984 USGS study which focused on the river and its tributaries between Curwensville and Renovo. The project documented that the pH of the river has increased significantly from its headwaters downstream to Lock Haven. Concentrations of acidity, iron, and aluminum have also been greatly reduced. In the 1970s, the river was predominantly or intermittently acidic and in 2009 it displayed a near net alkaline condition despite the continued contribution of acidity from more than 40 tributaries.

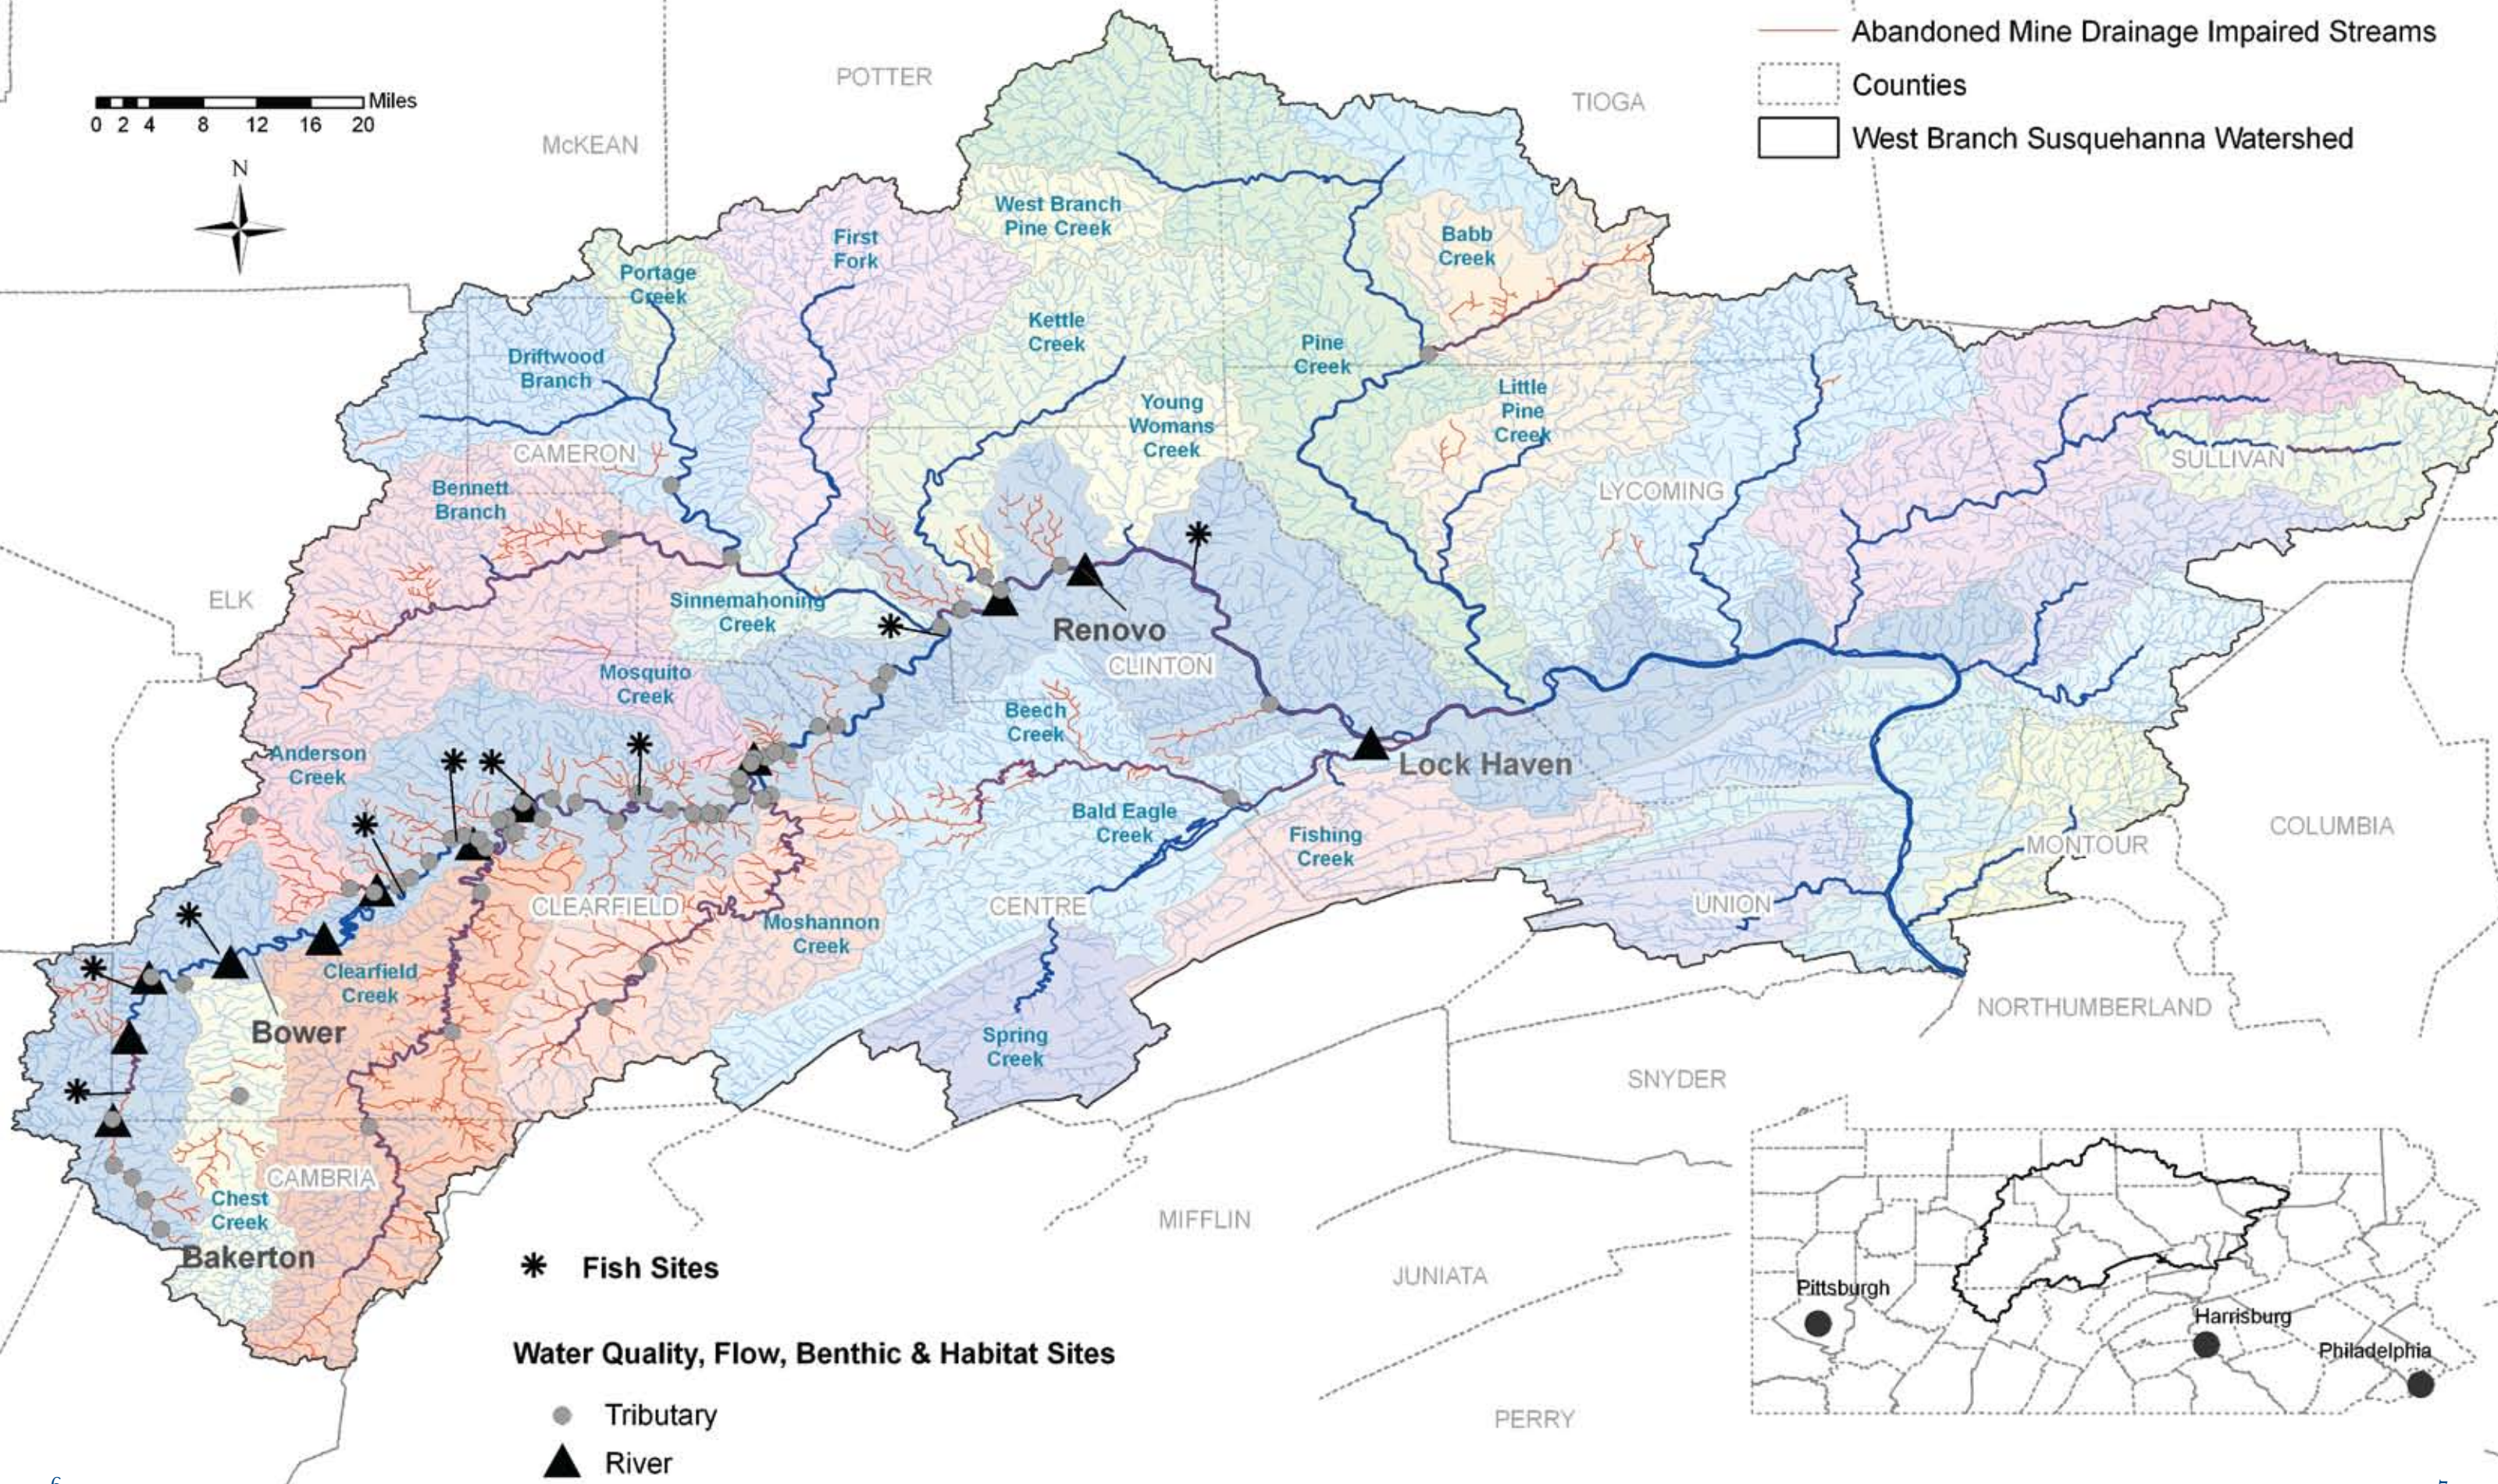
SITES SAMPLED IN 2009

- Abandoned Mine Drainage Impaired Streams
- Counties
- West Branch Susquehanna Watershed

- * Fish Sites**
- Water Quality, Flow, Benthic & Habitat Sites**
- Tributary
- ▲ River

Water samples were collected at 80 sites on the West Branch Susquehanna River and its AMD-impacted tributaries from its headwaters downstream to Lock Haven, as well as selected sites within larger subwatersheds. In 1984, the U.S. Geological Survey (USGS) surveyed 48 of the same sites between Curwensville and Renovo for AMD impairment. Water samples were analyzed by an accredited laboratory for the standard suite of AMD parameters such as total metal concentrations of aluminum, iron, and manganese, as well as pH, specific conductance, acidity and alkalinity.

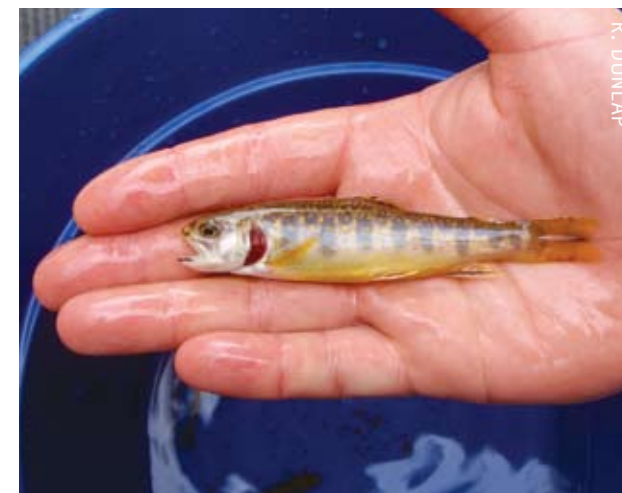
Brook trout found downstream of the Middle Branch passive treatment system, Kettle Creek.

On the other side of the scale, it was estimated that natural attenuation only accounted for just over 12% of the acidity decrease observed for Laurel Run. However, decades and centuries, in some instances, would be necessary to restore a stream by natural attenuation alone. One case in point would be Middle Branch – it would take 116 years for natural attenuation to achieve the same low levels of acidity currently measured in the stream that are a result of a passive AMD treatment system.

Finally, passive and active AMD treatment systems have played a key role in the improvement of water quality documented throughout the watershed. While data characterizing many of the treatment systems across the watershed were not readily available so that quantifying their cumulative effect on water quality improvement was not possible, individual examples point to the importance of water treatment toward overall water quality improvement. For example, multiple passive treatment systems and an active treatment facility have resulted in the return of a wild trout fishery to Babb Creek and the delisting of approximately 14 miles of Babb Creek and 5 miles of Pine Creek from Pennsylvania's list of impaired streams. A passive treatment system in the Sterling Run watershed resulted in the delisting of just over 12 miles of Sterling Run and the return of native brook trout to the stream. Additionally, Middle Branch in the lower Kettle Creek watershed is currently being sampled in consideration of delisting and water quality has improved enough that native brook trout have returned.

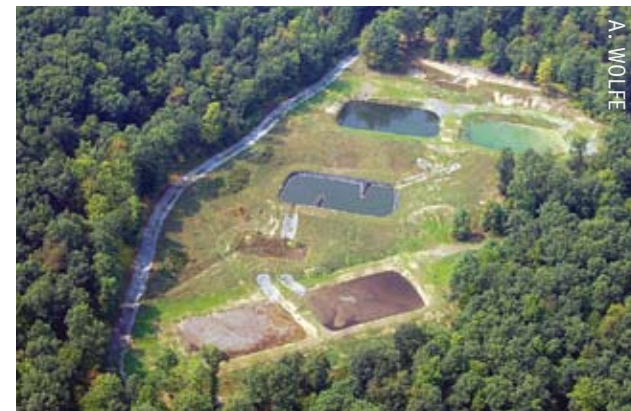
Middle Branch passive treatment system

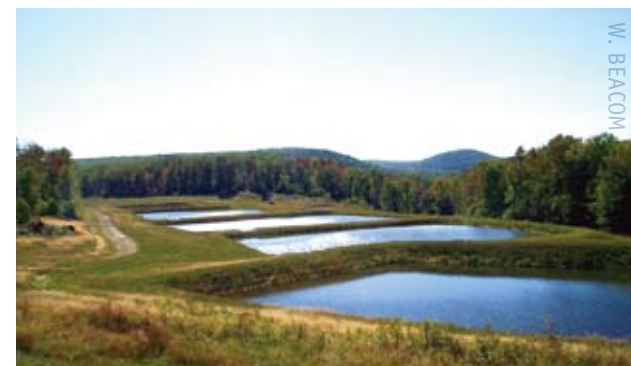
Anna S passive treatment system
